# Manhole Inspection Summary

Manhole # S43W\_\_031MH

Insp Date: **3/4/08 12:02 PM**

**Location** Address: **1447 lowman st.**

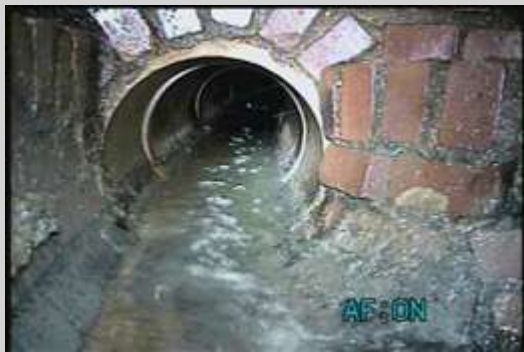
12 O'Clock Outflow

12 in. Circular Gravity Sewer  
Pipe Out @ 12 O'Clock

Pipe Material: **Clay** ☐ Pipe Lined

Invert Depth: **15.20** (ft.) Flow Characteristics: **Slow**

Deposits: ☒ None ☐ Mud ☐ Sludge ☐ Debris ☐ Grease

Infiltration: **None** Pipe Seal Cond: **Unknown**

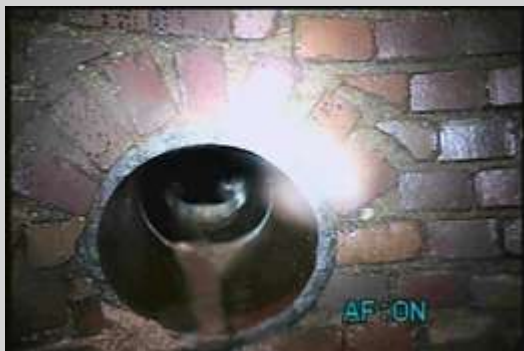
3 O'Clock Inflow

10 in. Circular Gravity Sewer  
Pipe In @ 3 O'Clock

Pipe Material: **Clay** ☐ Pipe Lined

Invert Depth: **11.80** (ft.) Flow Characteristics: **Fast**

Deposits: ☒ None ☐ Mud ☐ Sludge ☐ Debris ☐ Grease

Infiltration: **None** Pipe Seal Cond: **Unknown**

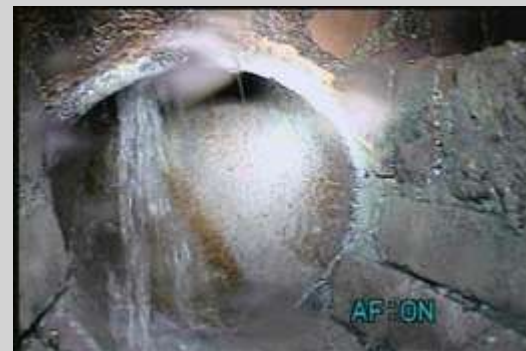
Drop In @ 3 O'Clock

Drop: **Inside** **Direct**

Inv Depth: **14.90** (ft.)

Drop Condition: **Open**

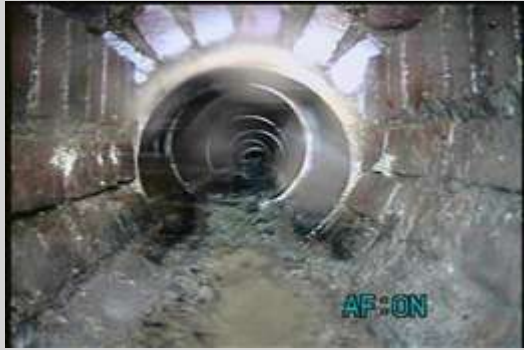
6 O'Clock Inflow

12 in. Circular Gravity Sewer  
Pipe In @ 6 O'Clock

Pipe Material: **Clay** ☐ Pipe Lined

Invert Depth: **15.00** (ft.) Flow Characteristics: **Slow**

Deposits: ☒ None ☐ Mud ☐ Sludge ☐ Debris ☐ Grease

Infiltration: **None** Pipe Seal Cond: **Unknown**
